TEST REPORT

REPORT NUMBER
190910159GZU-002

SUBJECT: Performance testing
<100mm Sliding Door>

| TEST METHODS AND STANDARDS |
|--|
| Refer to NZS 4211: 2008 - Specification for performance of windows (Amdt 1-2014) |

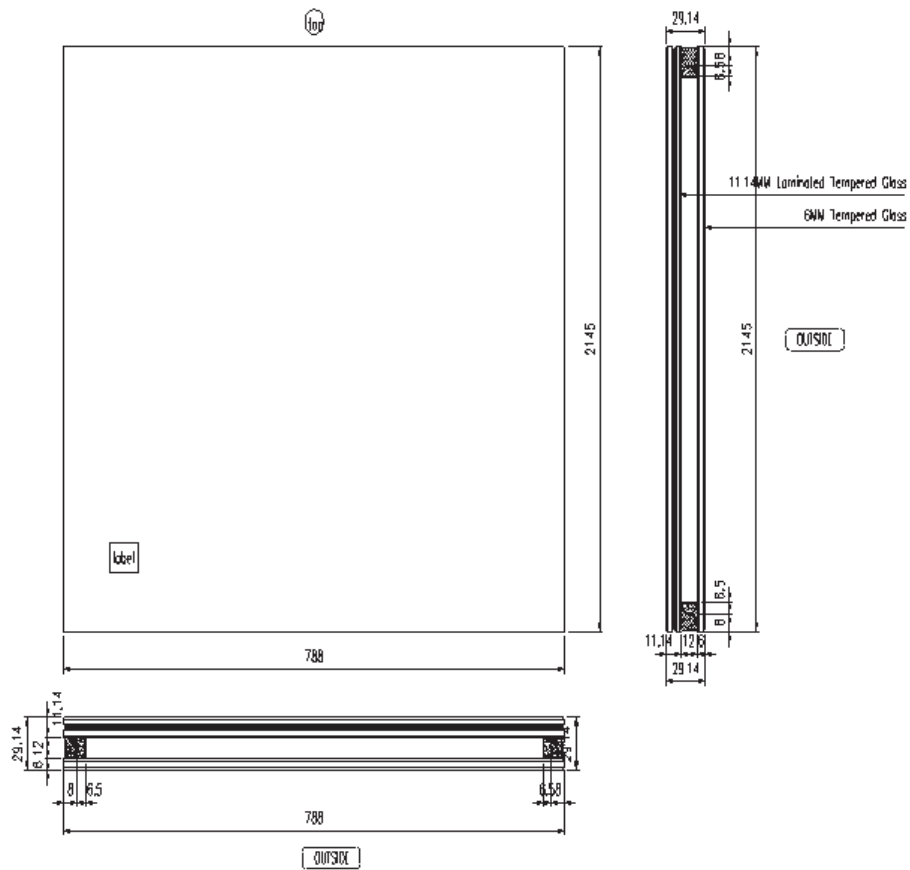
Fig.6 Drawing of Glazing Structure

| 8 | Glazing | Dimension: 788(Width) x 2145 mm (Height) quantity: 4 Structure: 5mm+1.14PVB+5mm+12A+6mm tempered double glazing Supplier: Guangdong SunGlass |

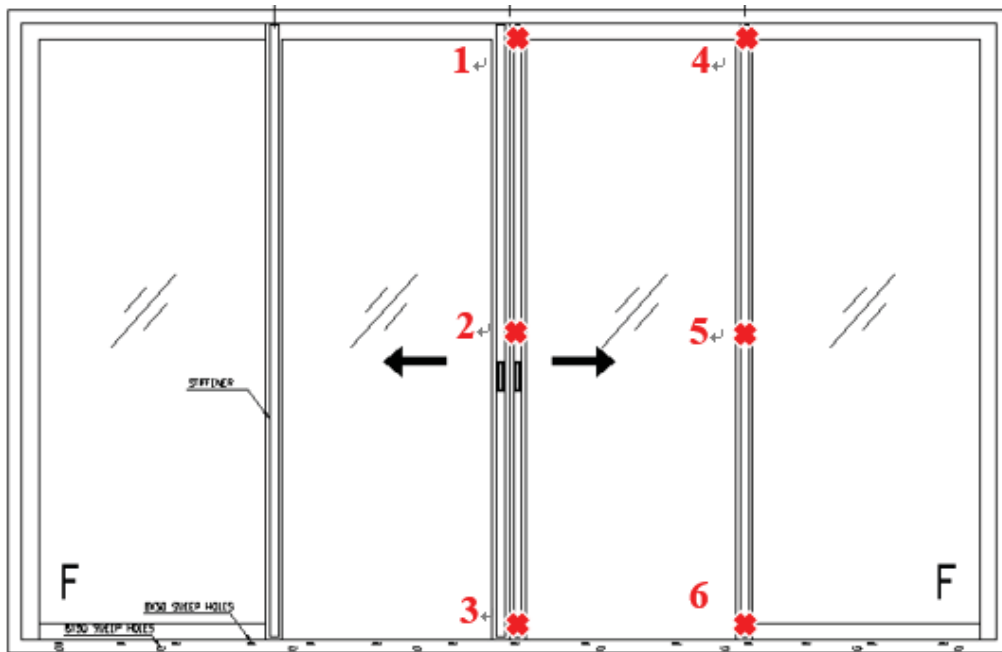
Fig.8 Locations of Displacement Measuring Devices

Table 3 Test Data of Deflection Test

| Member (mm) | | Test Pressure (Pa) | Deflection(mm) | | | Actual Deflection | Deflection/Span Ratio |
| Item | Span Length | | 1 | 2 | 3 | | |

Table 4 Test Data of Deflection Test

| Member (mm) | | Test Pressure (Pa) | Deflection(mm) | | | Actual Deflection | Deflection/Span Ratio |
|---|---|---|---|---|---|---|---|
| Item | Span Length | | 4 | 5 | 6 | | |
